Whitman County Harlan Bridge

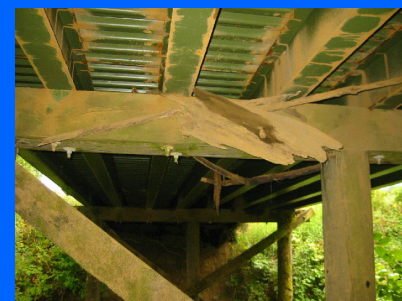
Evidence of High Water Level & Leaking Deck

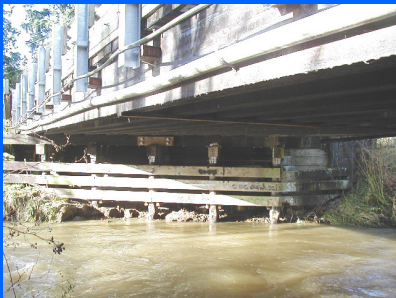
Timber Repairs and Scour

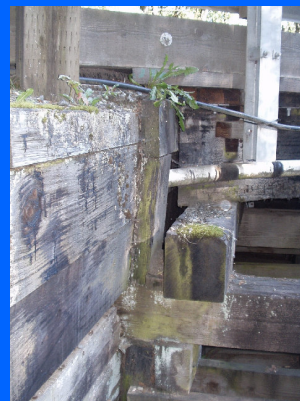
Deteriorating
Timber Abutment
and Backwall

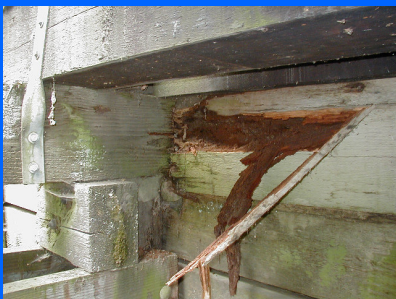
Rotten Failing Abutment Timbers

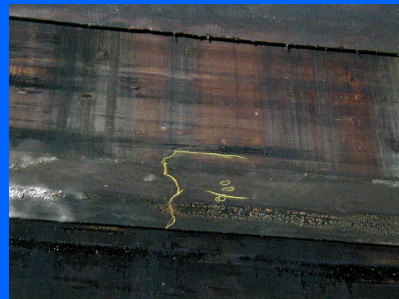
Glu-Lam Delamination and Failure of Bottom
Lam

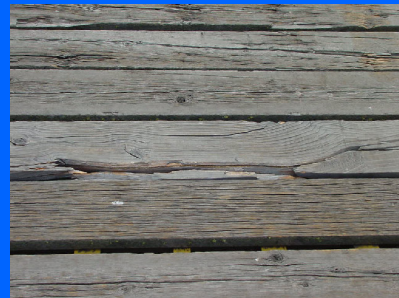
Deck Condition

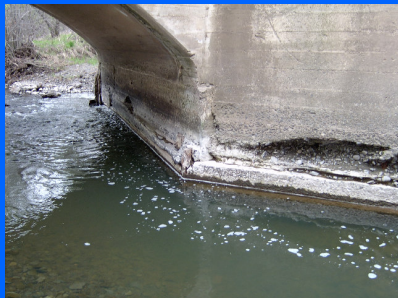
Abutment Condition and Scour

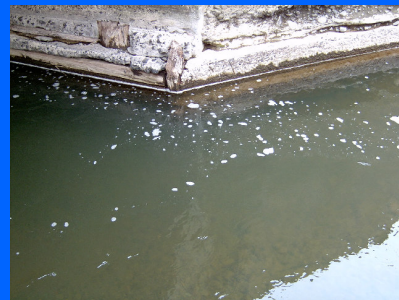
Foundation Deterioration

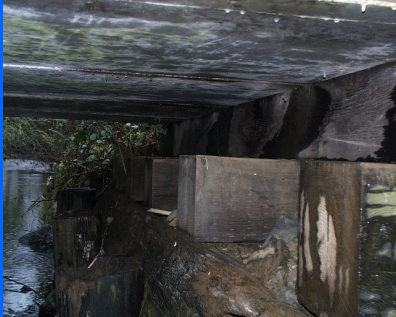
Abutment Repairs

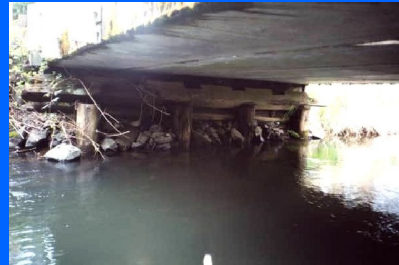
Log Raft Abutment

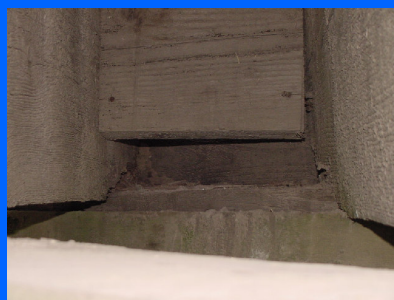
Failing Stringers Supported by Temp. Bent

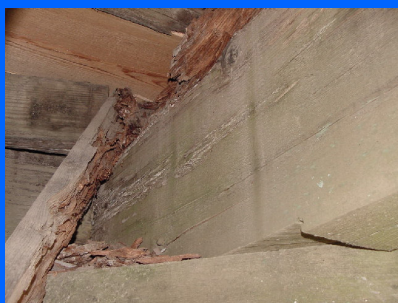
Rotten Failing Stringers

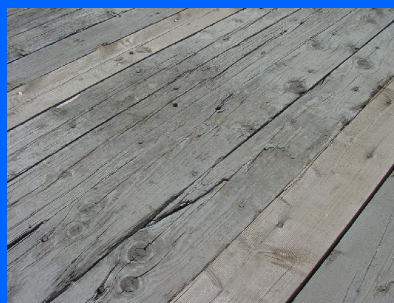
Typical Deck Condition

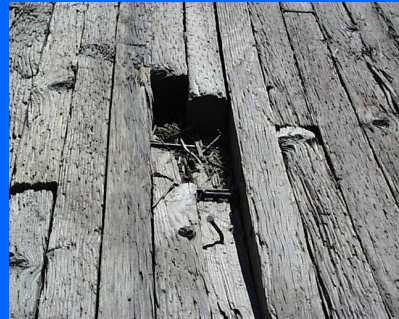
Deck Condition

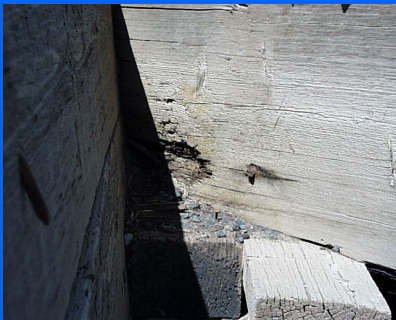
Rotten Stringers

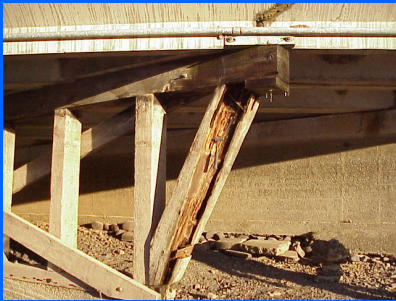
Timber Deterioration and Scour

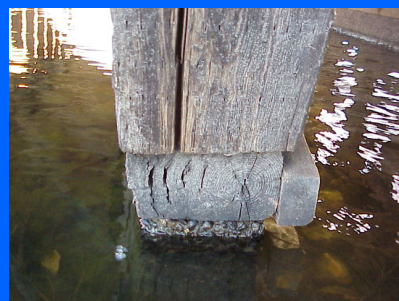
Timber Crushing at Mudsill

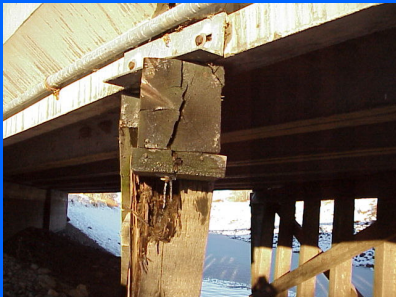
Substructure Damage

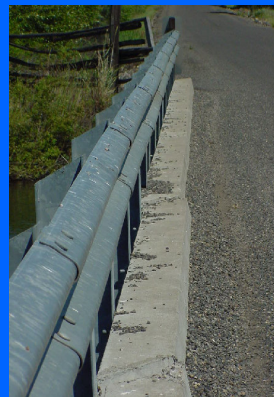
**Misalignment of
Superstructure**

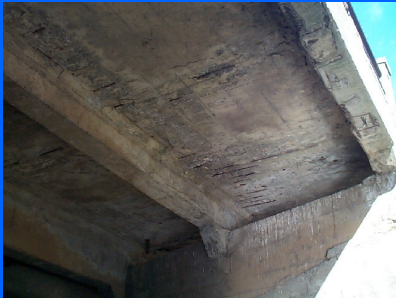
Concrete Deterioration Under Sidewalk

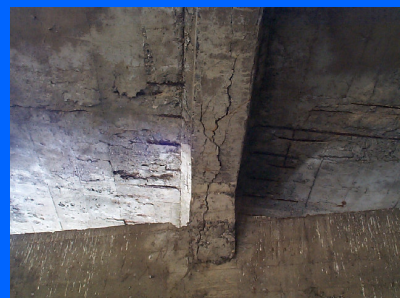
Outside Concrete Beam Deterioration

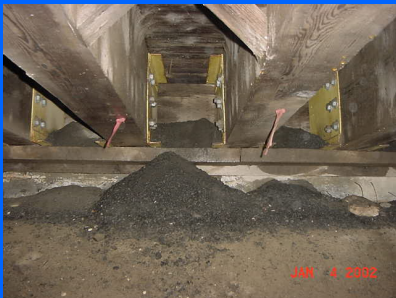
Repair to Reinforce Failing Stringers

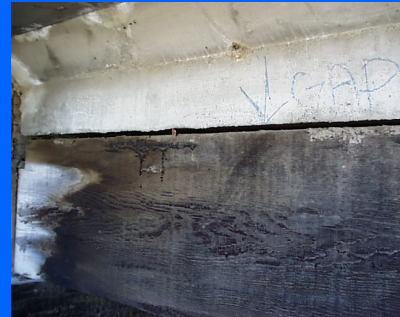
Sagging Timber Stringers

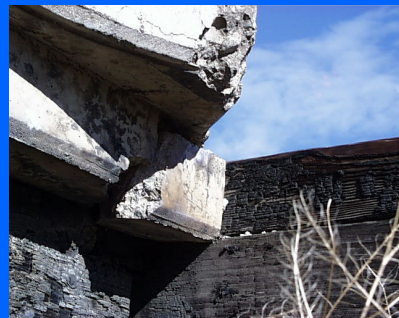
Superstructure Concrete Deterioration

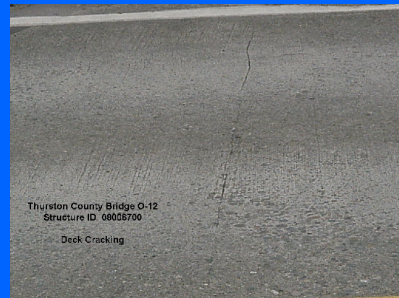
Typical Deck Cracking

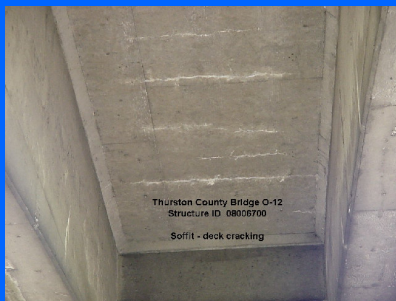
Soffit Cracking – Rebar Exposure Starting

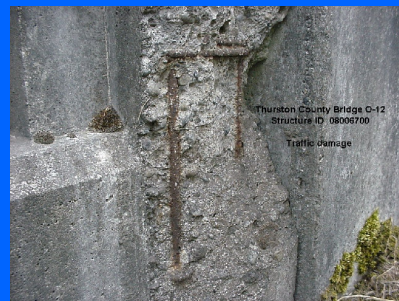
Traffic Damage to Narrow Bridge

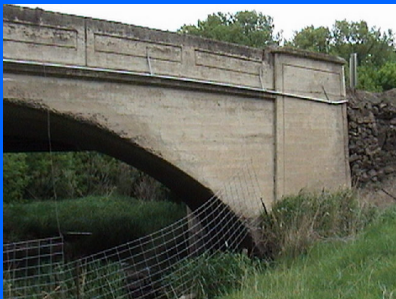
Riprap Repair to Retain Approach Fill

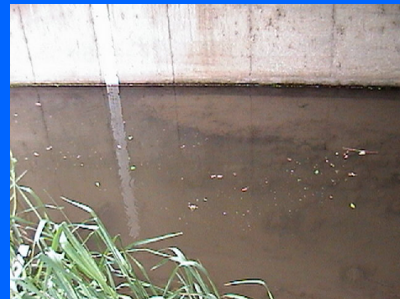
Scour Exposing Footing – Steel Side

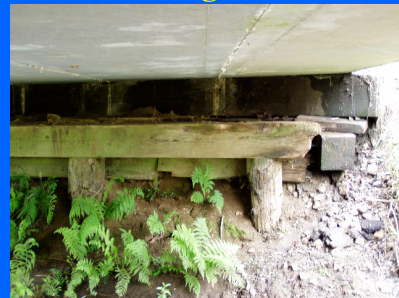
Repaired Mudsill Continues to Deteriorate

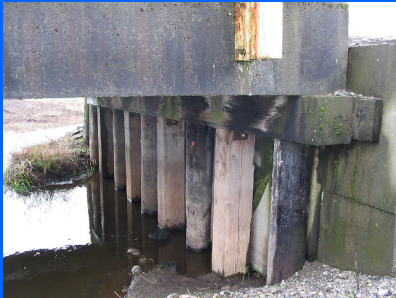
Repaired Substructure Continues to Deteriorate

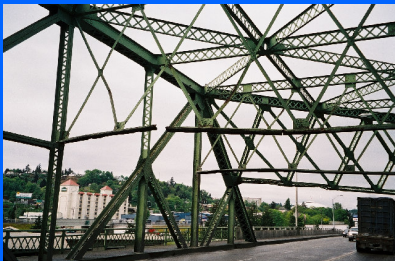
Typical High Load Damage

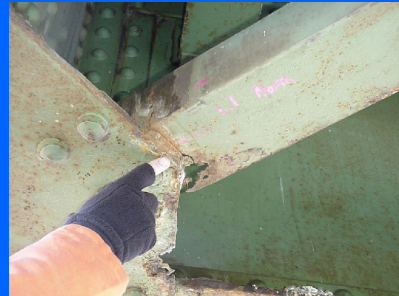
Typical Corrosion

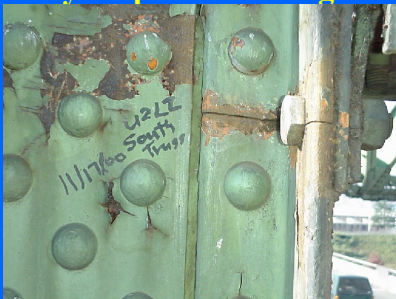
Critical Damage (Has Been Repaired)

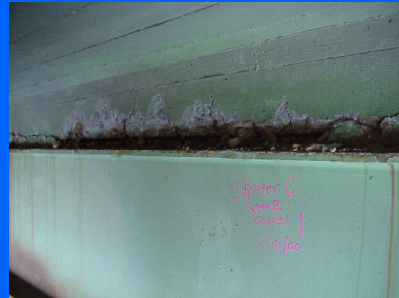
Deteriorated Concrete at Steel Stringer Interface

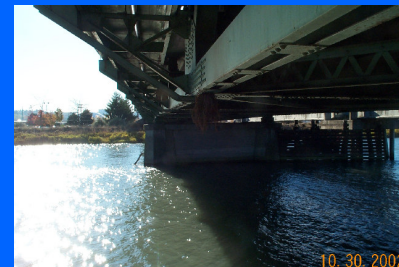
Intermediate Pier with Drift Accumulation

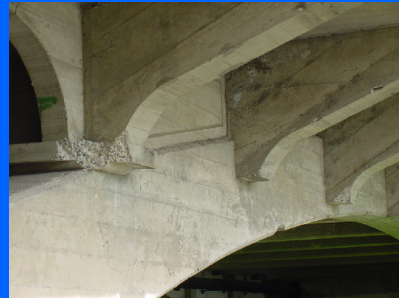
High Water Drift Damage

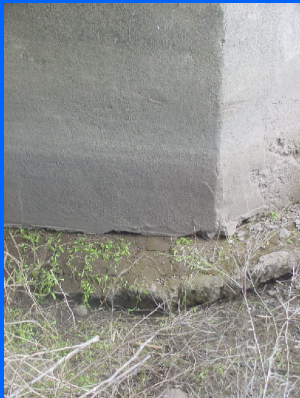
Abutment Scour

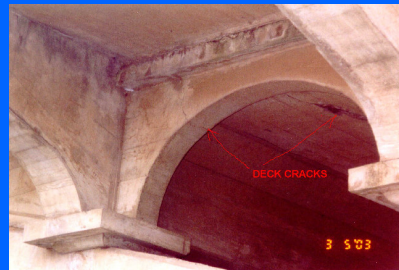
Concrete Cracks and Deterioration

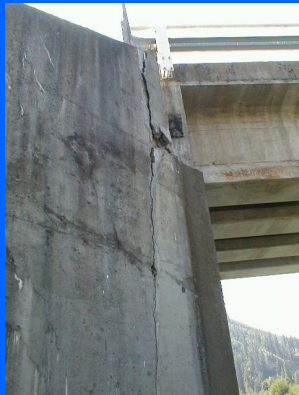
**Abutment Damage
due to Settlement
Caused by Scour**

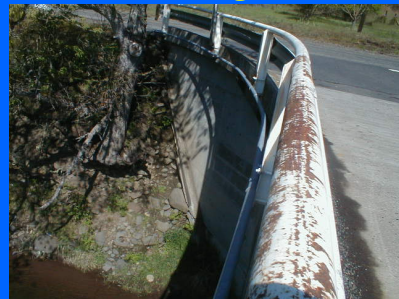
Scour at Abutment Wingwall

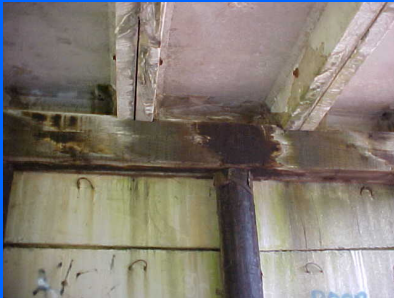
Ecology Block Backwall & Water Staining

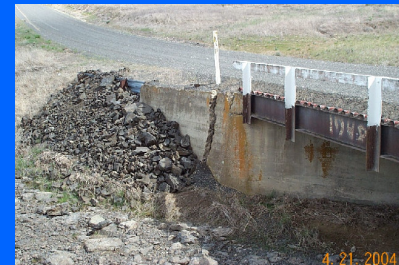
Abutment Cracking and Riprap Repair

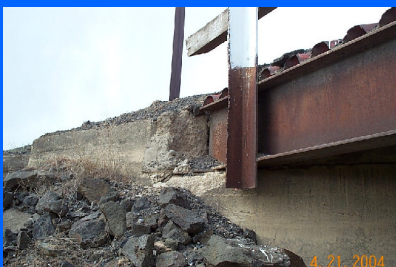
Bearing Damage

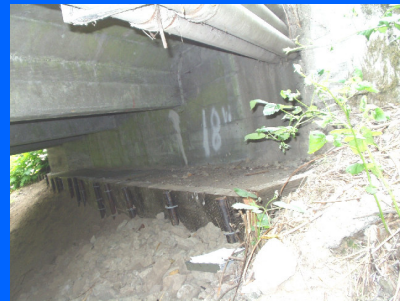
Pinpile Repair
